# CASE STUDY

## Bio-fuels

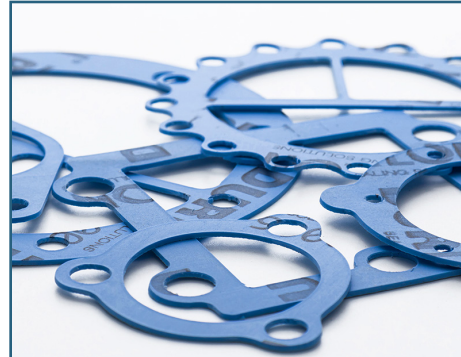
Durlon® 9000, 1/8" cut gaskets

The end-user purchased Durlon® 9000 at a local distributor, as it is a glass-filled PTFE gasket made with Teflon® polymers, and is a high performer in aggressive chemical applications. In addition, the shape of the fillers do not allow wicking which can cause corrosion on flange surfaces.
